Wrong-Way Movements on Divided Highways

PETER N. SCIFRES
Graduate Instructor in Research
and

ROY C. LOUTZENHEISER
Research Engineer
Joint Highway Research Project
Purdue University

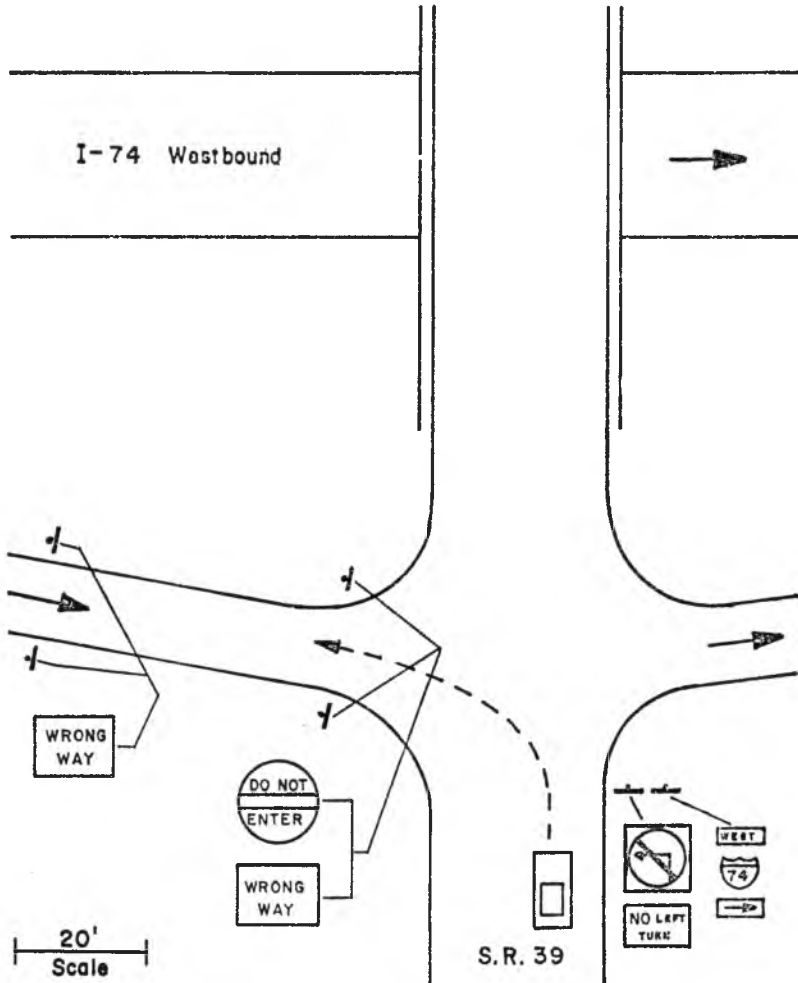
Fig. 6. The Interchange of I-74 and State Road 39—A Typical Diamond Interchange Where a Wrong-Way Movement Occurred.

Diamonds and Parcels—Figure 6 illustrates a typical wrong-way access point of this category. It is in a diamond interchange providing access to Interstate 74 from State Road 39. The crossroad is two-lane, undivided, and the exit ramp has wrong-way signing. Area land-use is light. The driver who made the wrong-way movement here was very old and apparently became confused as he asked a gas station attendant for directions three times. While it was not possible to assign a certain cause to this wrong-way movement, the driver's reduced ability was probably a major factor.

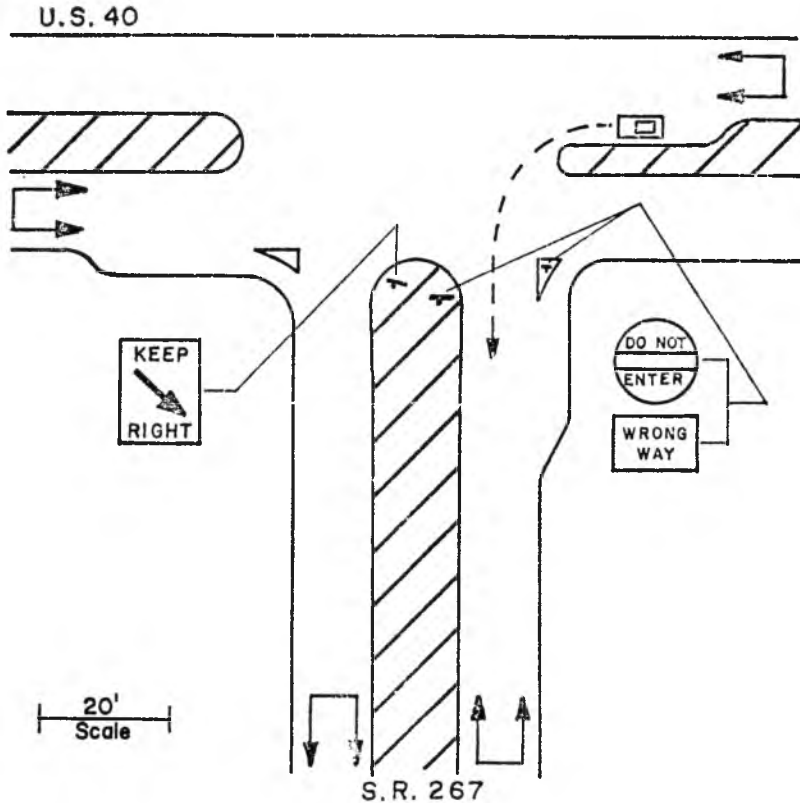
Major Intersections—In Figure 7, the intersection of U.S. 40 and State Road 267, one of the major intersection category where a wrong-way movement began, is shown. Although the intersection's signing is good, the width of the median does not permit the approaching driver to visualize the total intersection where vehicles on U.S. 40 must traverse a wide, unchannelized space to make a left turn correctly. The accident which originated here occurred at night and the lighting was poor. Some commercial development exists on U.S. 40 east of the intersection. The driver of the wrong-way vehicle was drunk.

This wrong-way movement was probably caused by a combination of poor lighting, the driver's condition, and the geometric layout of the intersection.

Fig. 7. The Intersection of U.S. 40 and State Road 267—A Major Intersection Where a Wrong-Way Movement Occurred.

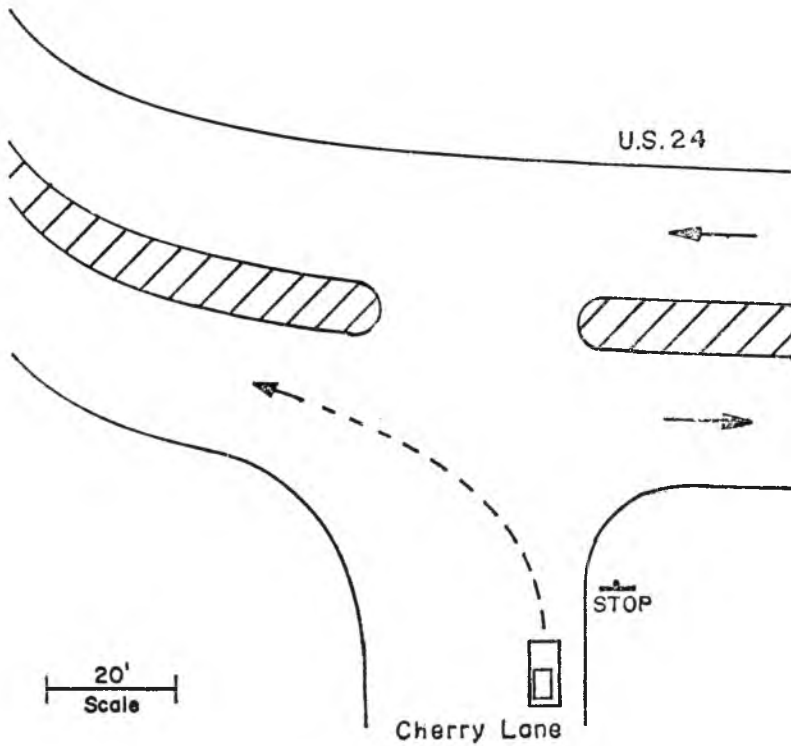
Minor Intersections—The intersection of U.S. 24 and Cherry Lane near Fort Wayne (Figure 8) is a minor intersection providing access from a residential area to U.S. 24. Although overall intersection visualization is very good, the intersection lacks any type of directional signing. The accident here occurred on a dark, rainy night with very low visibility. With no directional signing, the driver apparently became confused and made a left turn into the wrong lanes.

Fig. 8. The Intersection of U.S. 24 and Cherry Lane—A Typical Minor Intersection Where Wrong-Way Movement Occurred.

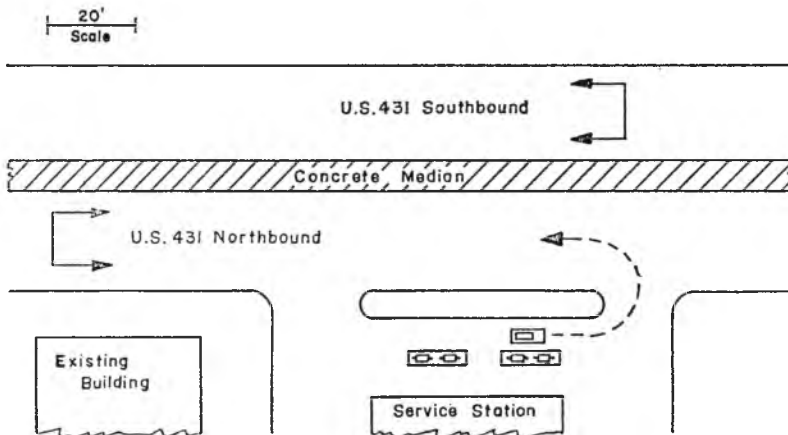
Fig. 9. Driveway on U.S. 431—Typical Driveway Where a Wrong-Way Movement Occurred.

Driveways—A typical wrong-way movement originating from a driveway is shown in Figure 9. There was no directional signing and it is likely that a directional, channelized driveway exit could have prevented the wrong-way movement which began here.

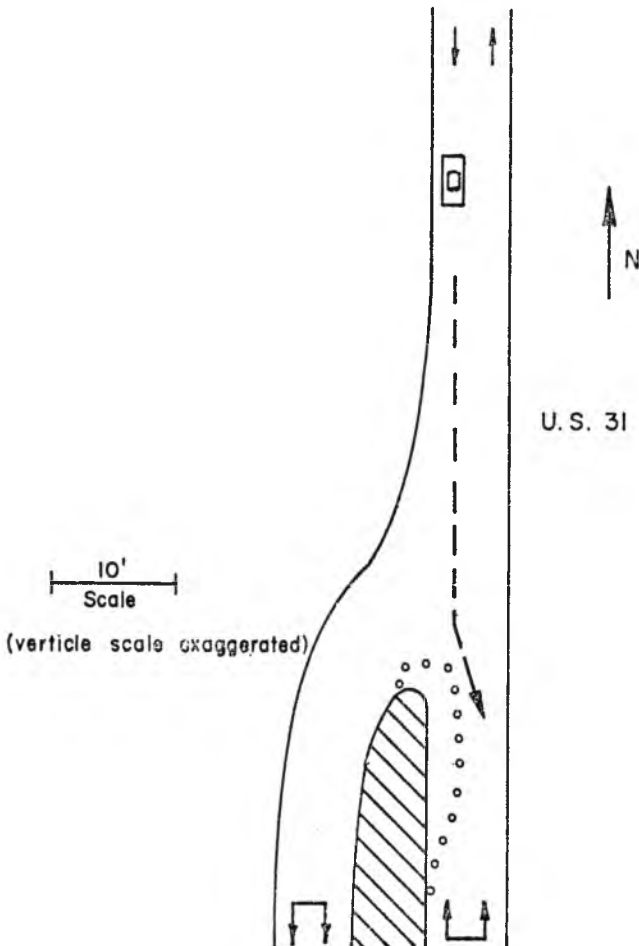
Fig. 10. Transition on U.S. 31—Site of Seven Wrong-Way Accidents.

Transitions—Seven accidents occurred at the transition on U.S. 31 north of Kokomo (Figure 10). This transition, used before all of U.S. 31 was improved to a divided, four-lane highway, had a configuration conducive to wrong-way movements. Vehicles approaching the four-lane section had to bear right to avoid driving into the wrong lanes of the divided highway. Most of the accidents also happened at night. Generally, the configuration of this transition and the inability of the driver to see the overall transition area were responsible for its wrong-way movement problem.

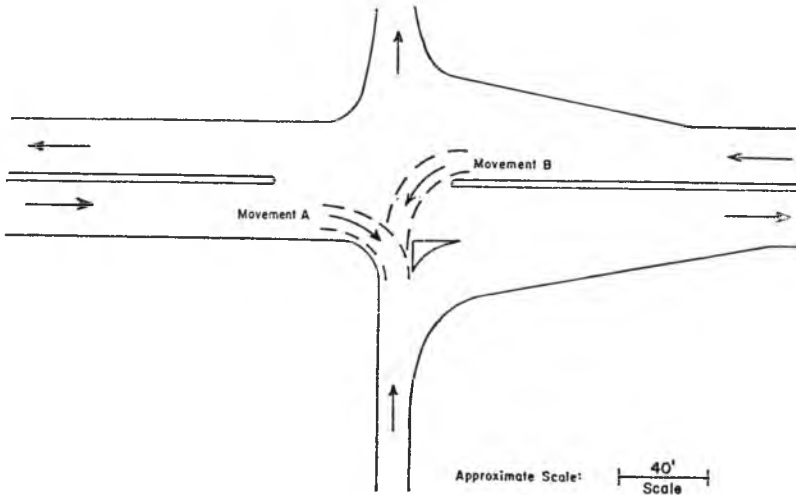
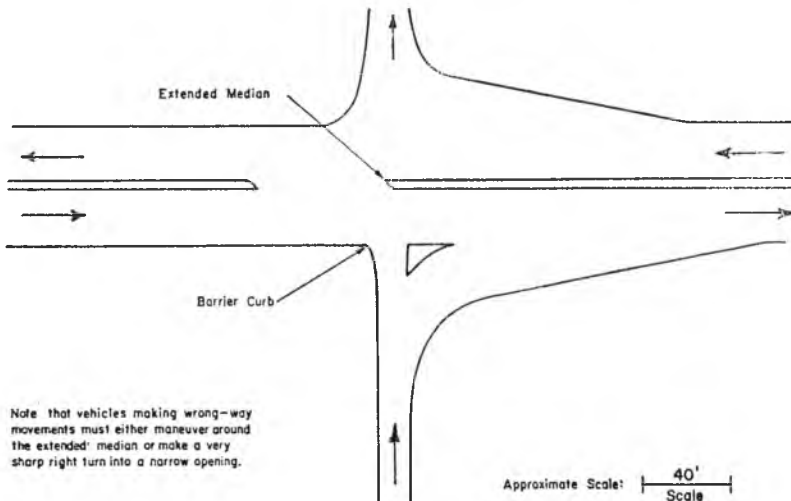
In Figure 11, a wrong-way right turn would be far more difficult or impossible if the curb on the right side of the vehicle was barrier-

Fig. 11. Wrong-Way Movements at a Divided Diamond Interchange.

Fig. 12. Wrong-Way Movement Prevention Modifications.

type and of very small radius. Also, the turn would be more difficult if the off-ramp opening was narrowed to approximately 12 feet and the island forming the other side of the opening was curbed. These possible design changes are shown in Figure 12. Likewise, the difficulty of a wrong-way left turn could be increased by extending the median nose across the off-ramp opening, thus blocking the opening from left-turning vehicles.

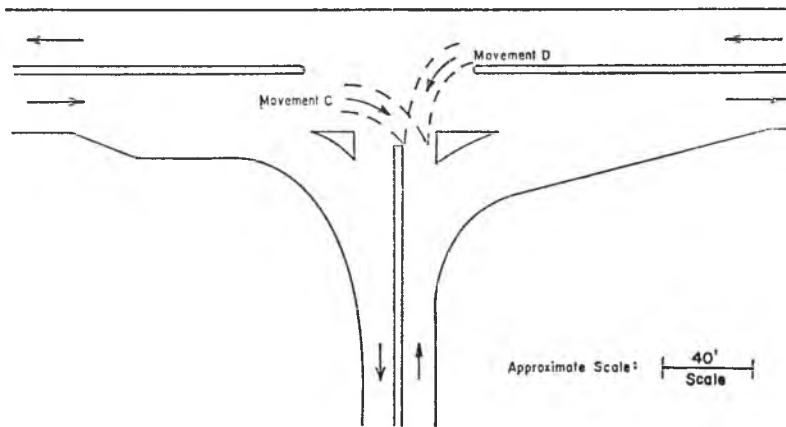
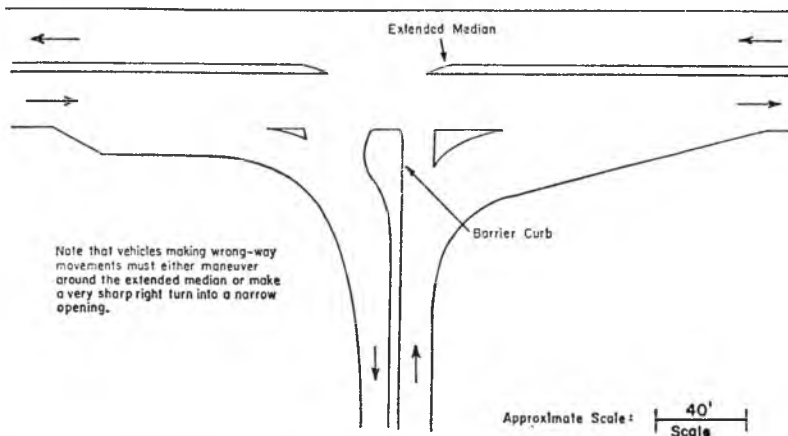
Similar techniques can be used to protect parclo off-ramp openings from wrong-way movements (see Figure 13). A wrong-way right turn would be made more difficult by shortening the right-hand curb radius

Fig. 13. Wrong-Way Movements at a Divided Parclo Interchange.

Fig. 14. Wrong-Way Movement Prevention Modifications for a Parclo Interchange.

to approximately two feet and narrowing the off-ramp opening to approximately 12 feet as was suggested for diamond interchanges (Figure 14). To prevent left turns into the wrong opening, the median should be extended to a point where it covers one-third to two-thirds of the off-ramp opening. The noted alterations would make wrong-way movements onto off-ramps a procedure that could only be accomplished with difficulty because of constraints imposed by vehicle-turning radii.

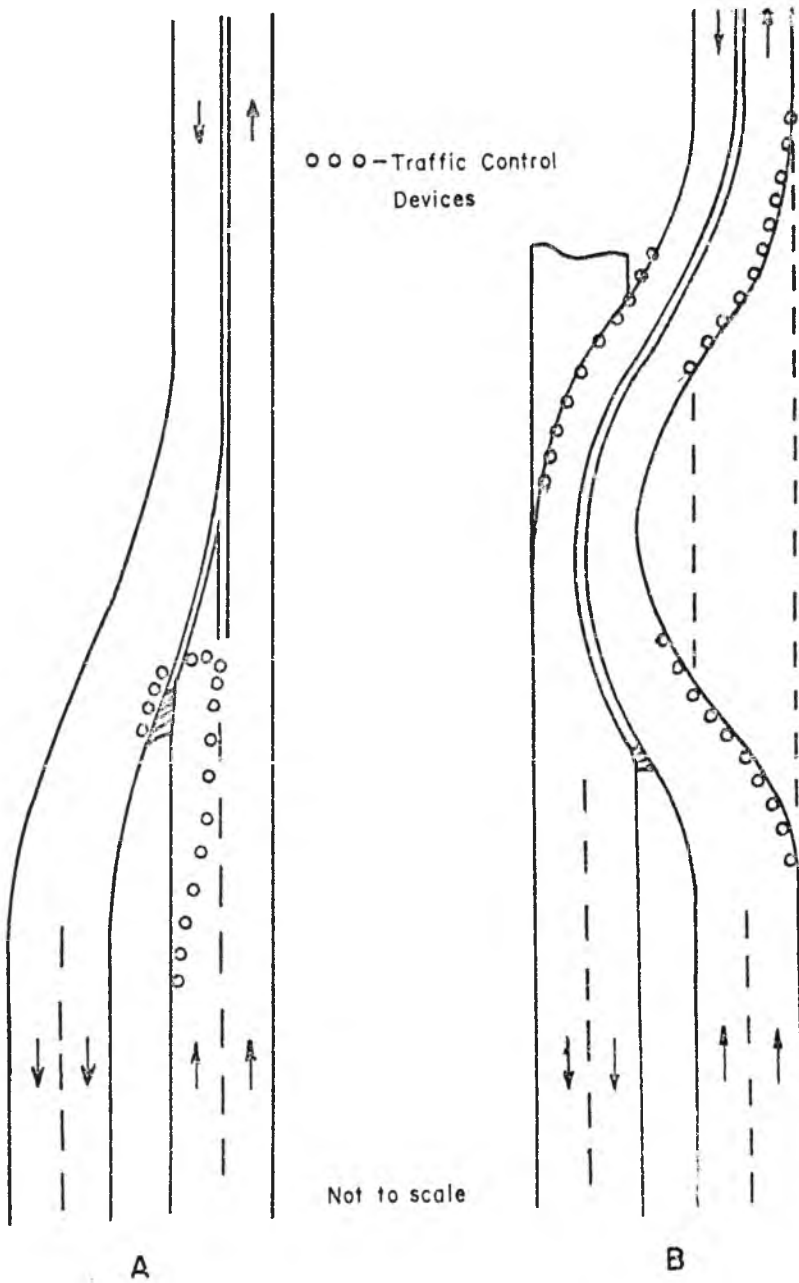
Fig. 16. Two Basic Transition Configurations.

problems. Figure 16 illustrates the two basic transition configurations. Configuration A is very poor design and should never be used as it requires drivers to read and understand signing instructing them to bear right to enter the transition in the right direction. This is not in accordance with the principles developed earlier, namely, that wrong-way movement prevention systems should not depend on signing. Configuration B is much better practice and should always be used.
